V-CAR[®] REPORT

A comprehensive vehicle valuation report focused on diminished value, as based directly on comparable sales data and the effects that collision repairs can have on vehicle condition ratings and market values.

Client: [REDACTED]
Vehicle Owner: [REDACTED]
Date of Loss: *October 17, 2018*
Year: *2017*
Make: *Volkswagen*
Model: *Golf Alltrac*
VIN: [REDACTED]

Diminished Value Summary Report

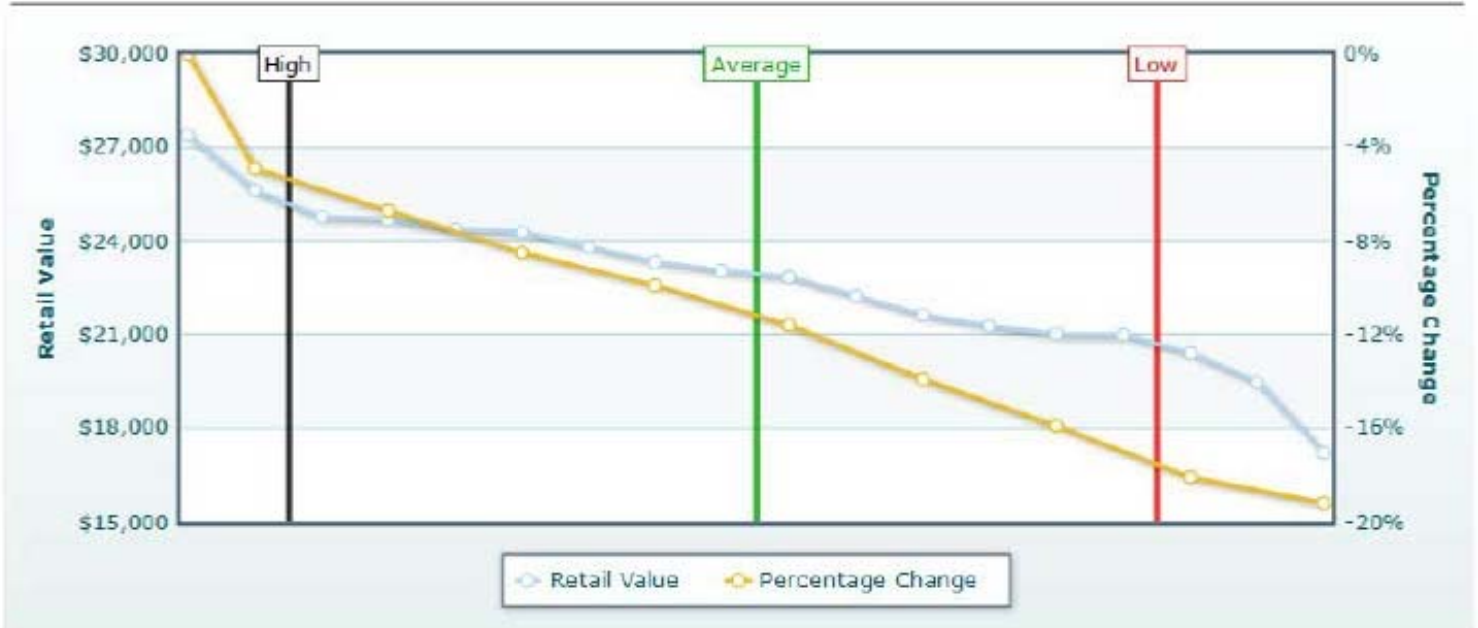
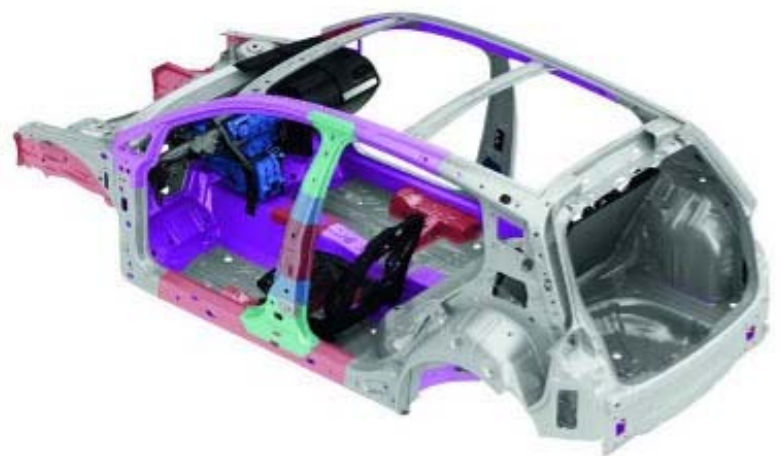
2017 VW Golf Alltrac Structure

Repair Classification	Line #:	Description	Hours
Frame and/or Structural Pull			
	1	Unibody Pull / Repair	2.0
		Frame and/or Structural Pull Total	2.0
Structural Body Repair			
	93	Left Outer Wheelhouse [Unibody] Panel	4.0
		Structural Body Repair Total	4.0
Welded/Bonded Panel Labor			
	82	Left Quarter Panel [Unibody]	22.6
		Welded/Bonded Panel Labor Total	22.6
Non-Structural Body Repair Labor			
	43	Left Front Door Shell	1.5
	52	Left Rear Door Shell [Replace]	4.7
	118	Pinch Welds	1.0
		Non-Structural Body Repair Labor Total	7.2
Refinish Labor			
		Total Refinish Time	21.5
		Refinish Labor Total	21.5
